Field Evaluation Of A Television Bore Hole Telescope

July 1966

State of California  
Business and Transportation Agency  
Department of Public Works  
Division of Highways

**NO. M & R 226468**

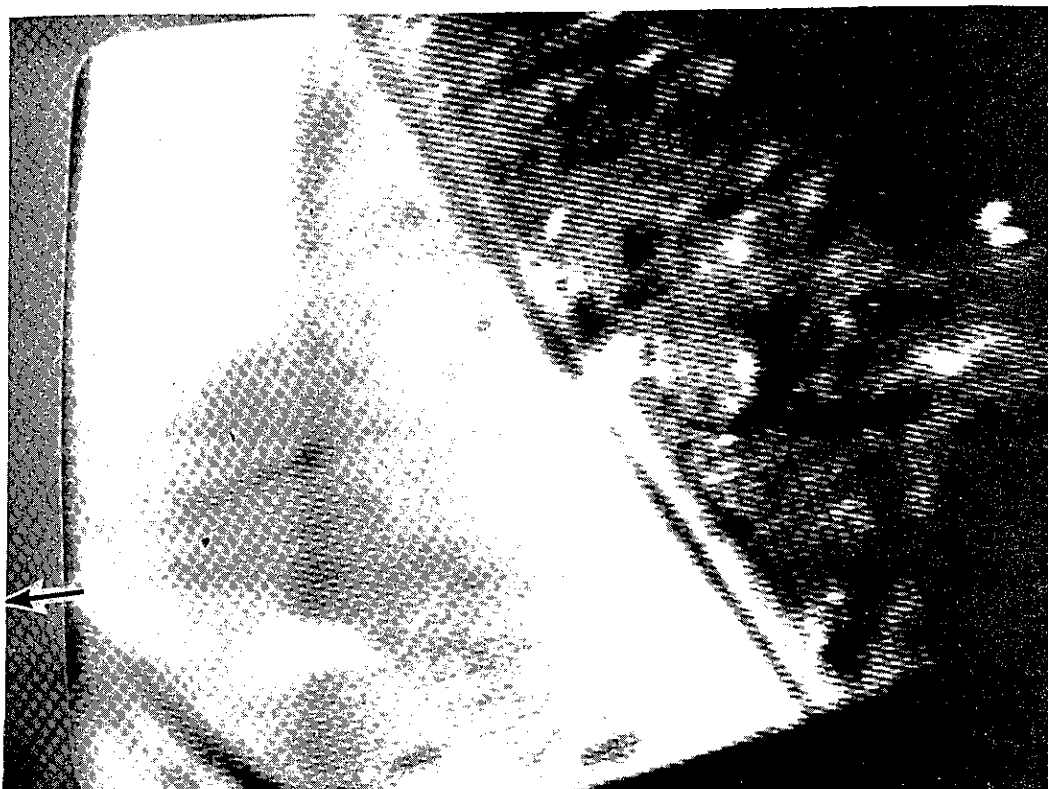
Photo 6 - Boring R-10 Santa Susana Pass 76.8 ft. Water table (light area). Mud slurry obscures boring wall.

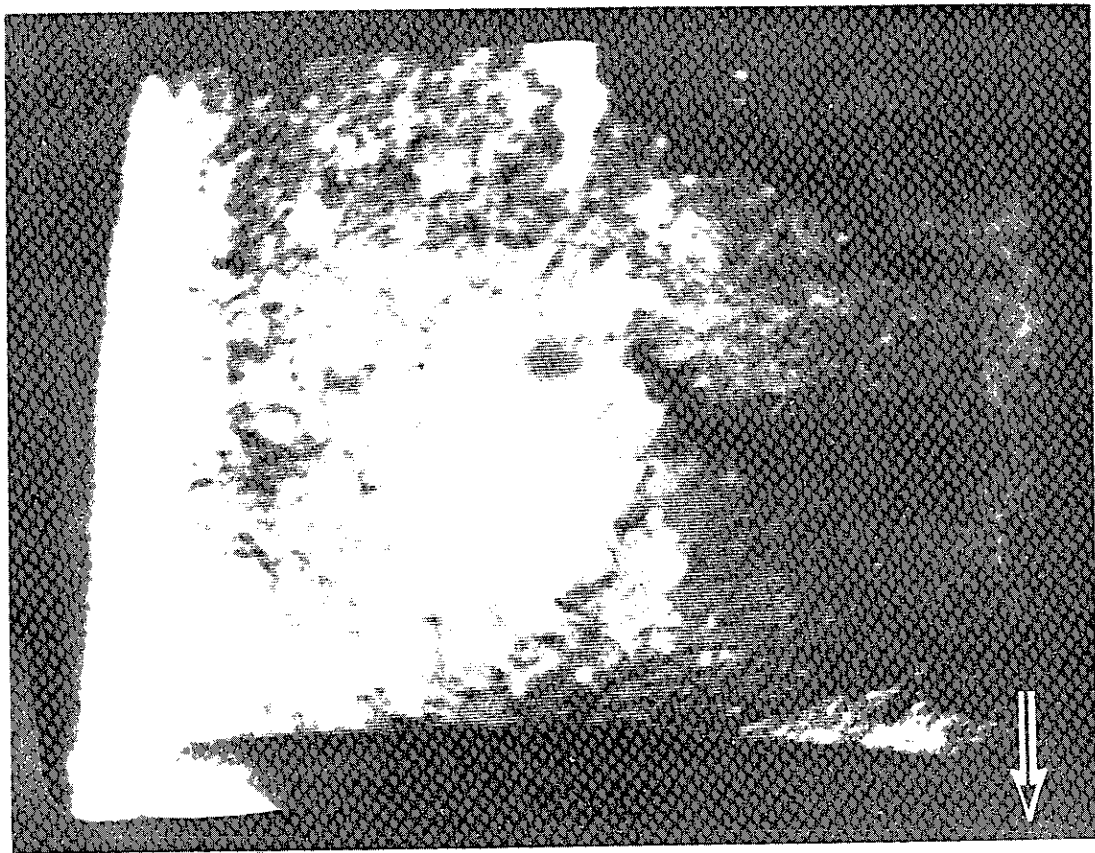
Photo 11 - Boring R-8 Santa Susana Pass 48.3 ft. Large void in sandstone.

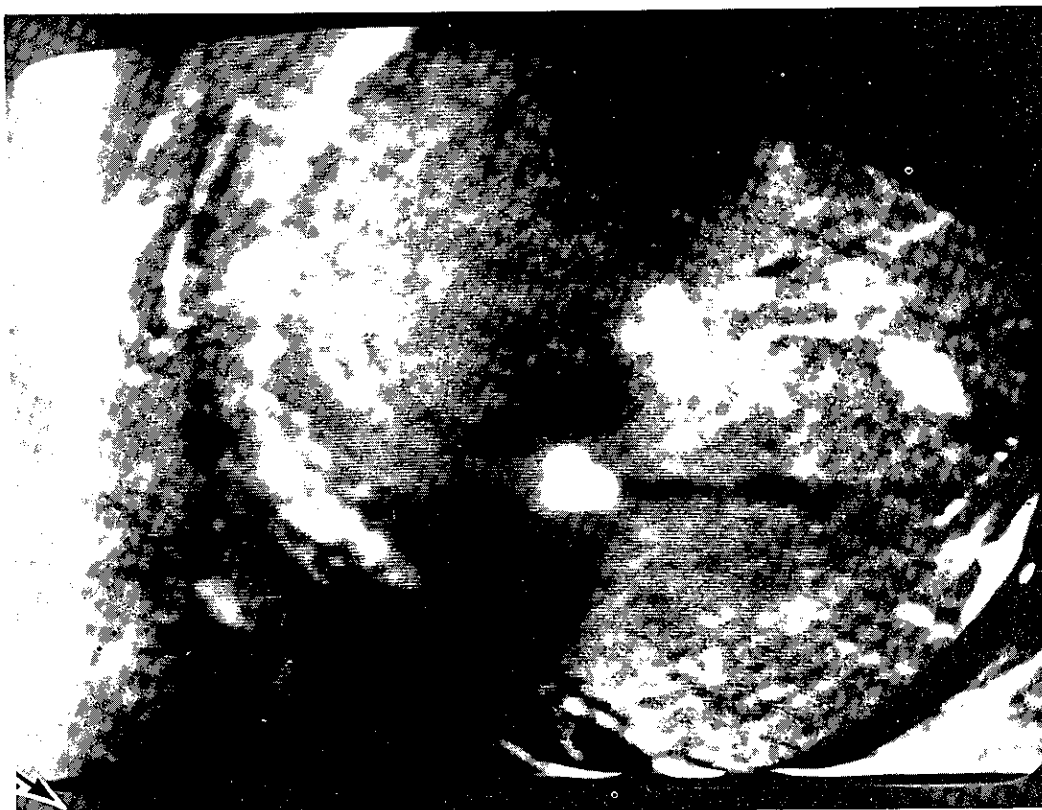
Photo 30 - Boring R-5 Anderson Grade 160.3 ft. Circular fracture healed with calcite.

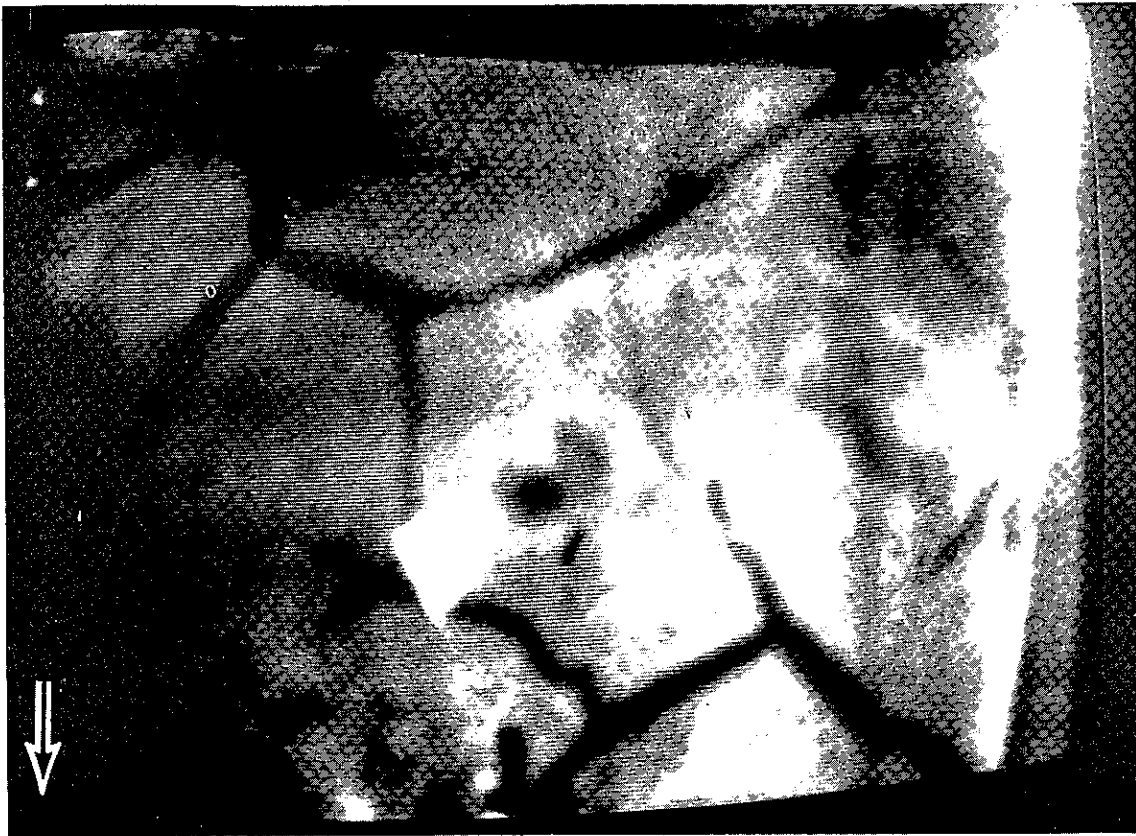
Photo 31 - Boring R-5 Anderson Grade 6.3 ft. Cracks in mud cake on boring wall.
